# Basilisk info sheet no. 3

## Project Europol parking garage

### Project overview:

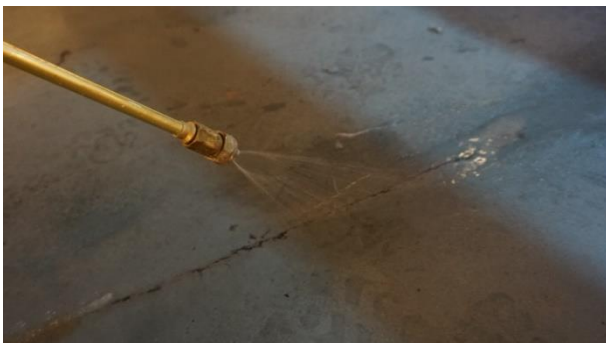
Figure 4 Application of the ER7 (Basilisk)

For the application of the ER7 on the 12.000 m<sup>2</sup> the surface area needed to be free of cars and other debris that could block off the cracks. To achieve this the parking garage was closed for an entire weekend and mechanically cleaned. In this weekend a team of six workers then manually applied the ER7 (Figure 4,5). This application was done by first applying two layers of component A followed by one layer of component B. After the curing period of six week this process was repeated.
